# Manhole Inspection Summary

Manhole # S130\_\_015MH

Insp Date: **3/19/08 10:04 AM**

**Location** Address: **500 S. Longwood St**

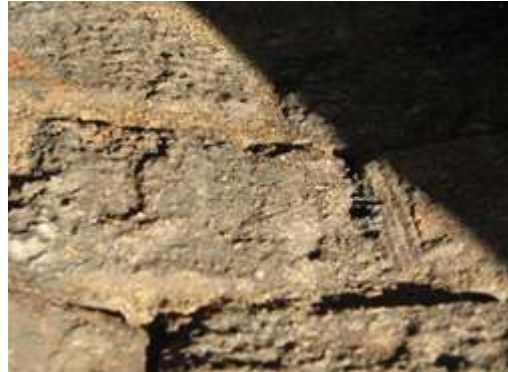
Defect 5

Condition: ☐ Sound ☐ Cracked ☐ Root Intrusion ☐ Loose Brick ☒ **Deteriorated**

deterioration of corbel

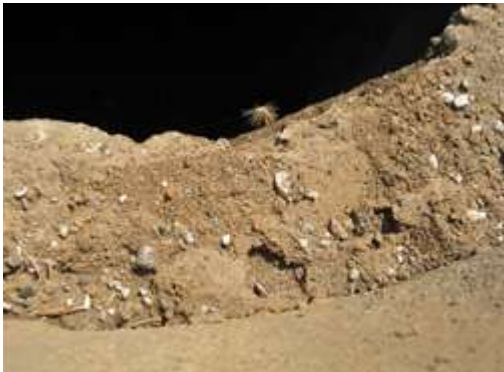
Defect 3

Offset: **3** (in.)

offset at rim and chimney

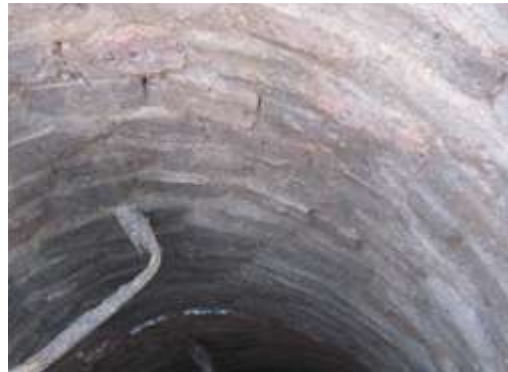
Defect 2

Infiltration: ☐ None ☐ Joint ☐ Cracks ☐ Mortar ☐ Roots ☒ **Wall**

infiltration at corbel wall

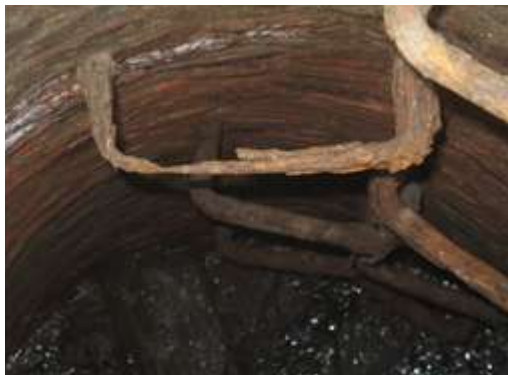
Defect 1

Count: **8** Missing: **0** ☒ **Corroded**

corroded steps

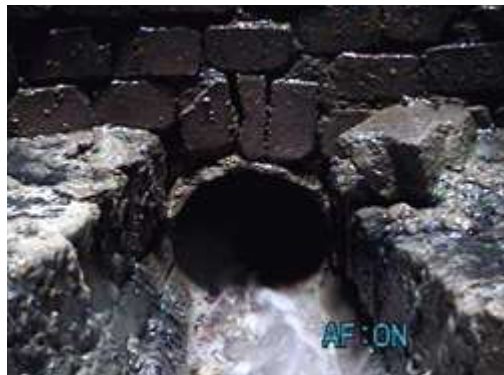
Defect 4

Condition: ☐ Sound ☐ Cracked ☐ Root Intrusion ☒ **Deteriorated** ☐ Leaks ☐ Debris

bench deteriorated

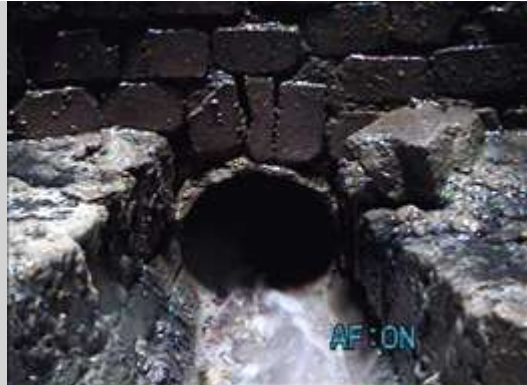
12 O'Clock Outflow

Pipe Height: **8.4** (in.) Rod and Bar (Angled)  
Pipe Material: **Clay** ☐ Pipe Lined  
Invert Depth: **13.10** (ft.) Flow Characteristics: **Fast**  
Deposits: ☒ None ☐ Mud ☐ Sludge ☐ Debris ☐ Grease  
Silt Depth: **0** (in.) Deposits Extent:  
Infiltration: **None** Pipe Seal Cond: **Unknown**

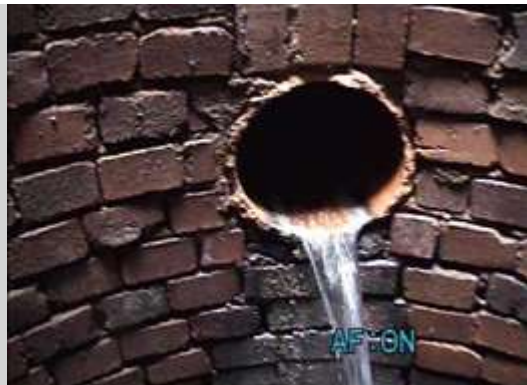
4 O'Clock Inflow

Pipe Height: **19.2** (in.) Rod and Bar (Angled)  
Pipe Material: **Clay** ☐ Pipe Lined  
Invert Depth: **10.28** (ft.) Flow Characteristics: **Fast**  
Deposits: ☒ None ☐ Mud ☐ Sludge ☐ Debris ☐ Grease  
Silt Depth: **0** (in.) Deposits Extent:  
Infiltration: **None** Pipe Seal Cond: **Sound**

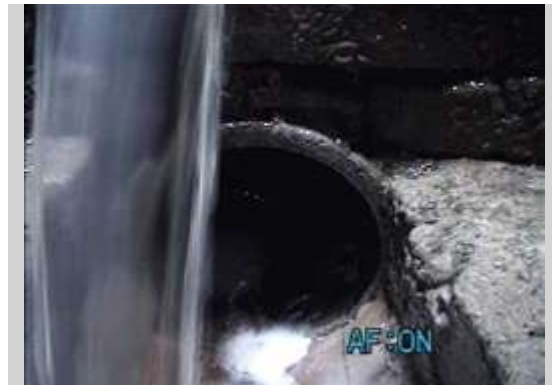
Drop In @ 4 O'Clock

Drop: **Inside** Rod and Bar  
Angled: **Yes** Reading: **11.76** (ft.)  
Inv Depth: **12.76** (ft.)  
Drop Condition: **Open**

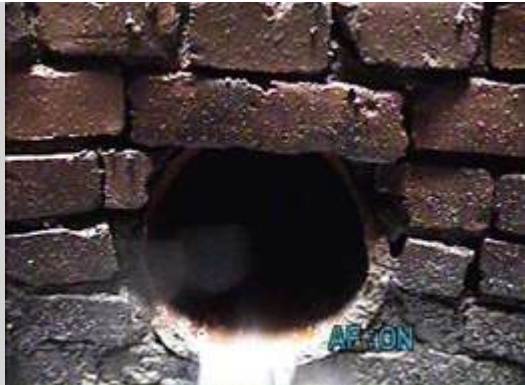
6 O'Clock Inflow

Pipe Height: **7.2** (in.) Rod and Bar (Angled)

Invert Depth: **12.72** (ft.) Flow Characteristics: **Slow**

Pipe Seal Cond: **Unknown**

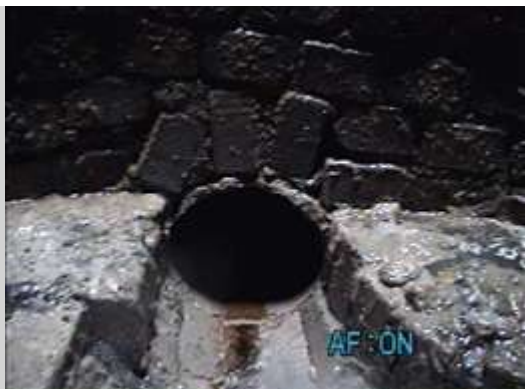
9 O'Clock Inflow

Pipe Height: **8.4** (in.) Rod and Bar (Angled)

Invert Depth: **12.64** (ft.) Flow Characteristics: **Slow**

Pipe Seal Cond: **Sound**
